REMEDIAL ACTION COMPLETION REPORT

ASBESTOS CONTAINING MATERIAL, LEAD-CONTAMINATED SOIL AND SEPARATOR

**Prewitt Refinery Site
Prewitt, NM**

**Atlantic Richfield Company/
El Paso Natural Gas Company**

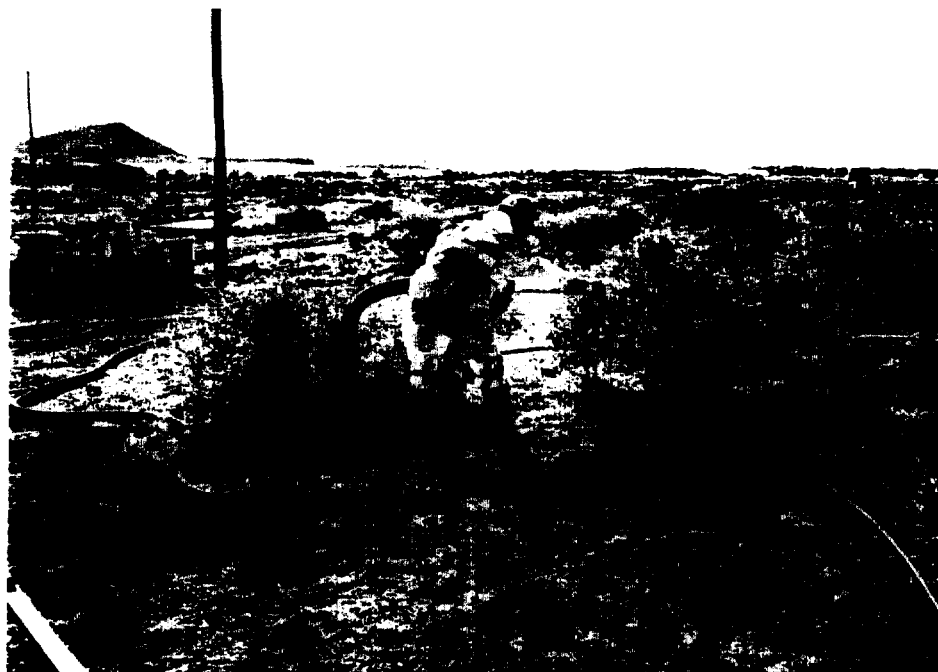
FIGURE 2-7 - Small Capacity Vacuum

The ACM removal was started with a small capacity vacuum as shown in Figure 2-7. The ACM was loaded directly into 55 gallon drums that were double lined with 6-mil plastic liners. This unit proved to be too limited for the task and was later replaced by a more powerful large capacity truck-mounted vacuum that loaded into large steel "roll-off" transportation bins (21' x 7.5' x 4') as shown in the photo in Figure 2-8. Approximately 7 cubic yards of ACM were removed with a small capacity vacuum and placed in 26 drums. The contents of these drums were subsequently transferred to a bladder in the roll-off bin using the large capacity vacuum.

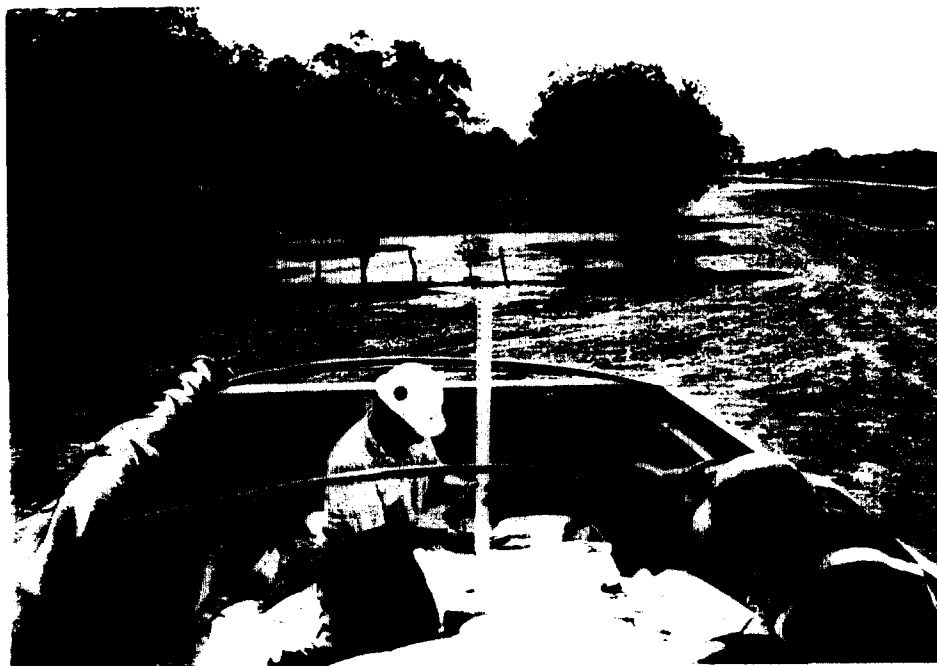
FIGURE 2-9 - SC/QAO Measurements for Waste Manifest

All ACM removed from locations with visible hydrocarbon staining was placed in separate bins designated for hydrocarbon contaminated ACM. Each "roll-off" transportation bin was equipped with a bladder with four openings along the top that could be attached to the outlet of the vacuum. After loading each bin, the RA Contractor and the SC/QAO measured the dimensions of the bladder to provide a volume for the waste manifest as shown in Figure 2-9.

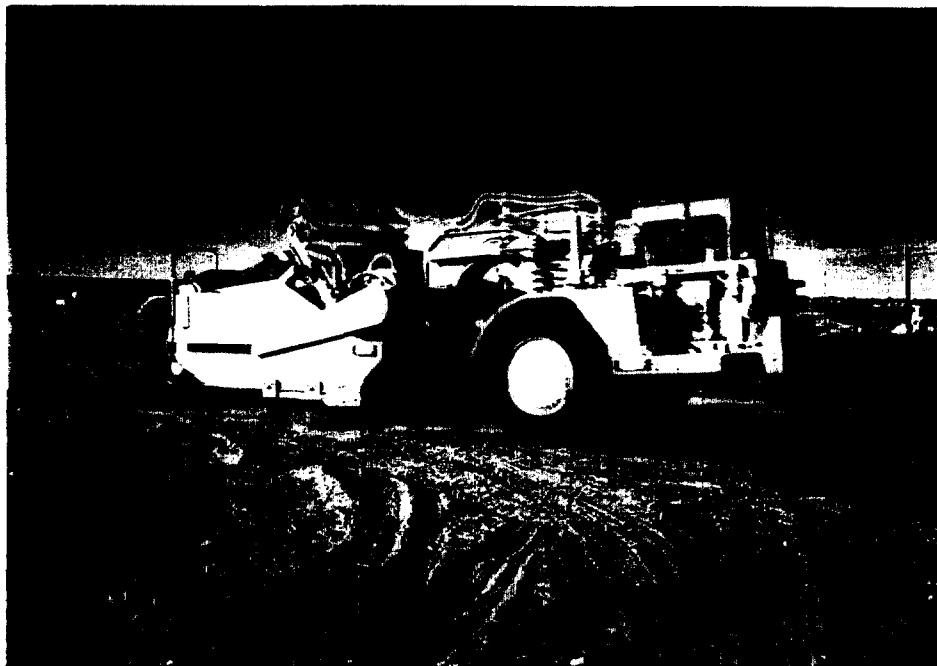
FIGURE 2-15 - Hauling of Backfill Soils

Backfill soils were hauled to the Site by scrapers as shown in Figure 2-15, and distributed over the excavated and disturbed areas. The Site was then graded and compacted with dozers as shown in Figure 2-16. Following grading, the area was fertilized and disked to reduce compaction and to incorporate the fertilizer into the subsurface as shown in Figure 2-17. The disked area was then seeded in accordance with the RD using conventional drilling methods. Straw mulch was applied after seeding.

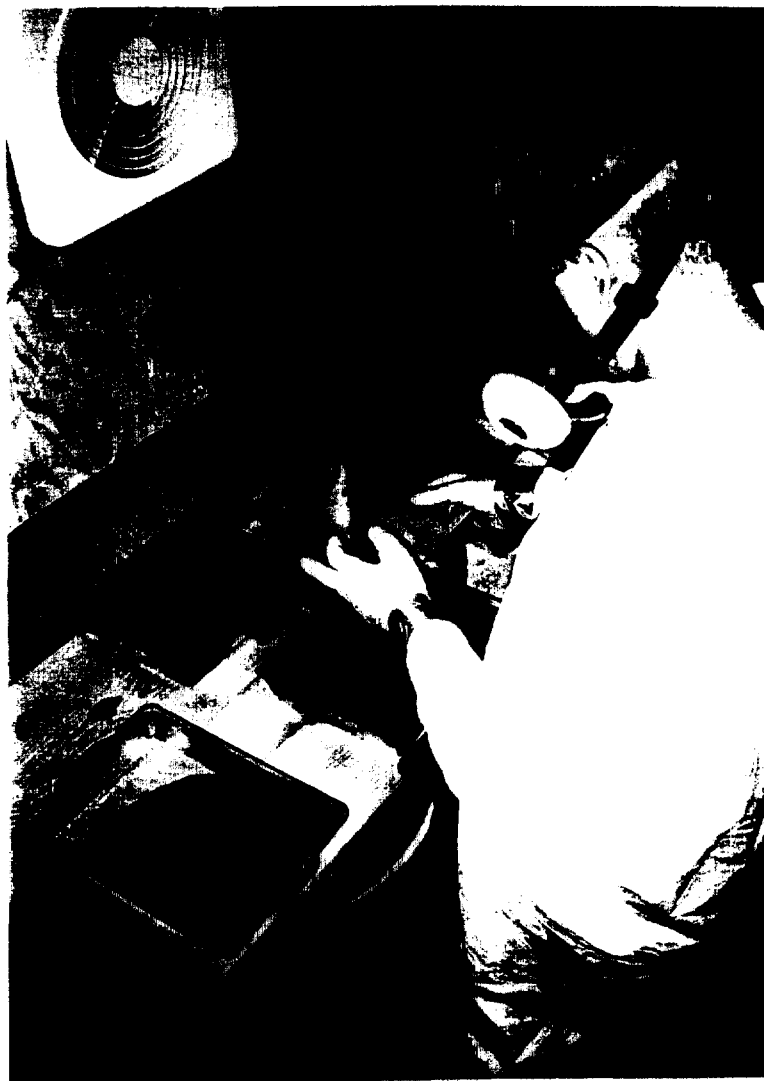
FIGURE 3-10 - Dividing Lead Soil Samples Using a Jones Sample Splitter

- Soil samples were collected in resealable plastic bags and labeled to indicate sample location and depth as prescribed by the sampling and analysis plan (SAP) of the RD.
- Samples were taken to the soil preparation area where samples were logged in and documented on chain of custody records, as shown in Figure 3-6.
- Samples were placed in steel pans and dried in an oven, as shown in Figure 3-7.
- Large rocks, roots, and organic debris was removed from the dried samples.
- Samples were run through a motorized jaw crusher at least two times, as shown in Figure 3-8.
- Samples were ground with a mortar and pestle and run through a 10-mesh sieve, as shown in Figure 3-9.
- Samples were blended in pans and divided into quarters using a Jones sample splitter. Opposite quarters were recombined and samples were split and recombined again, as shown in Figure 3-10.

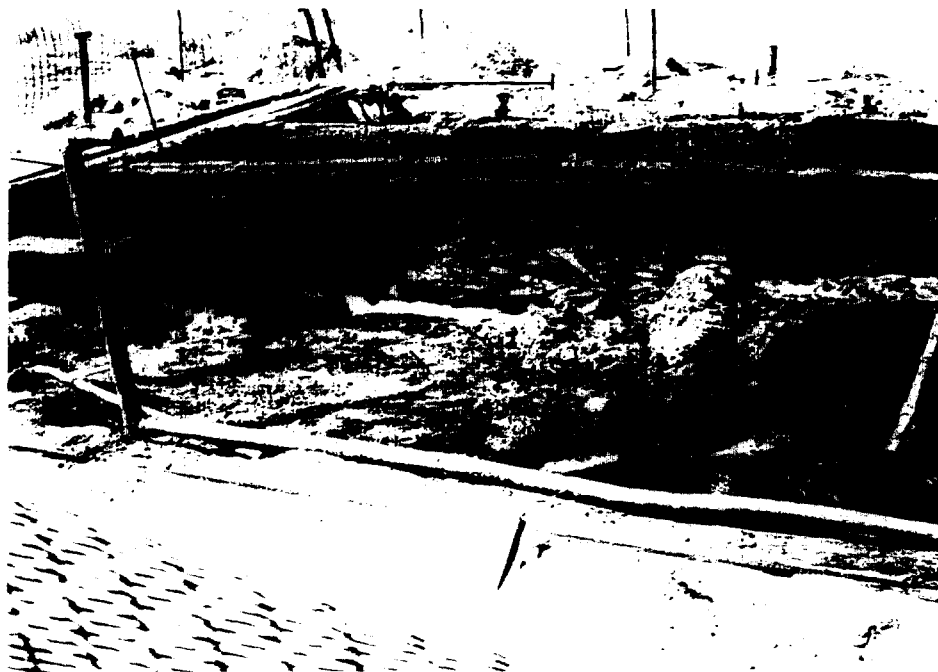
FIGURE 4-1 - Separator Before Remediation

The separator was in the north central portion of the Site fenced area, adjacent to old U.S. Route 66. The remedial action for the separator included the removal of the sludge contained in the separator, the metal secondary tank, ancillary piping and equipment, and any contaminated soil beneath the separator. The remedial action also involved either clean-up or removal of the main concrete structure. The separator prior to remediation is shown in Figure 4-1.

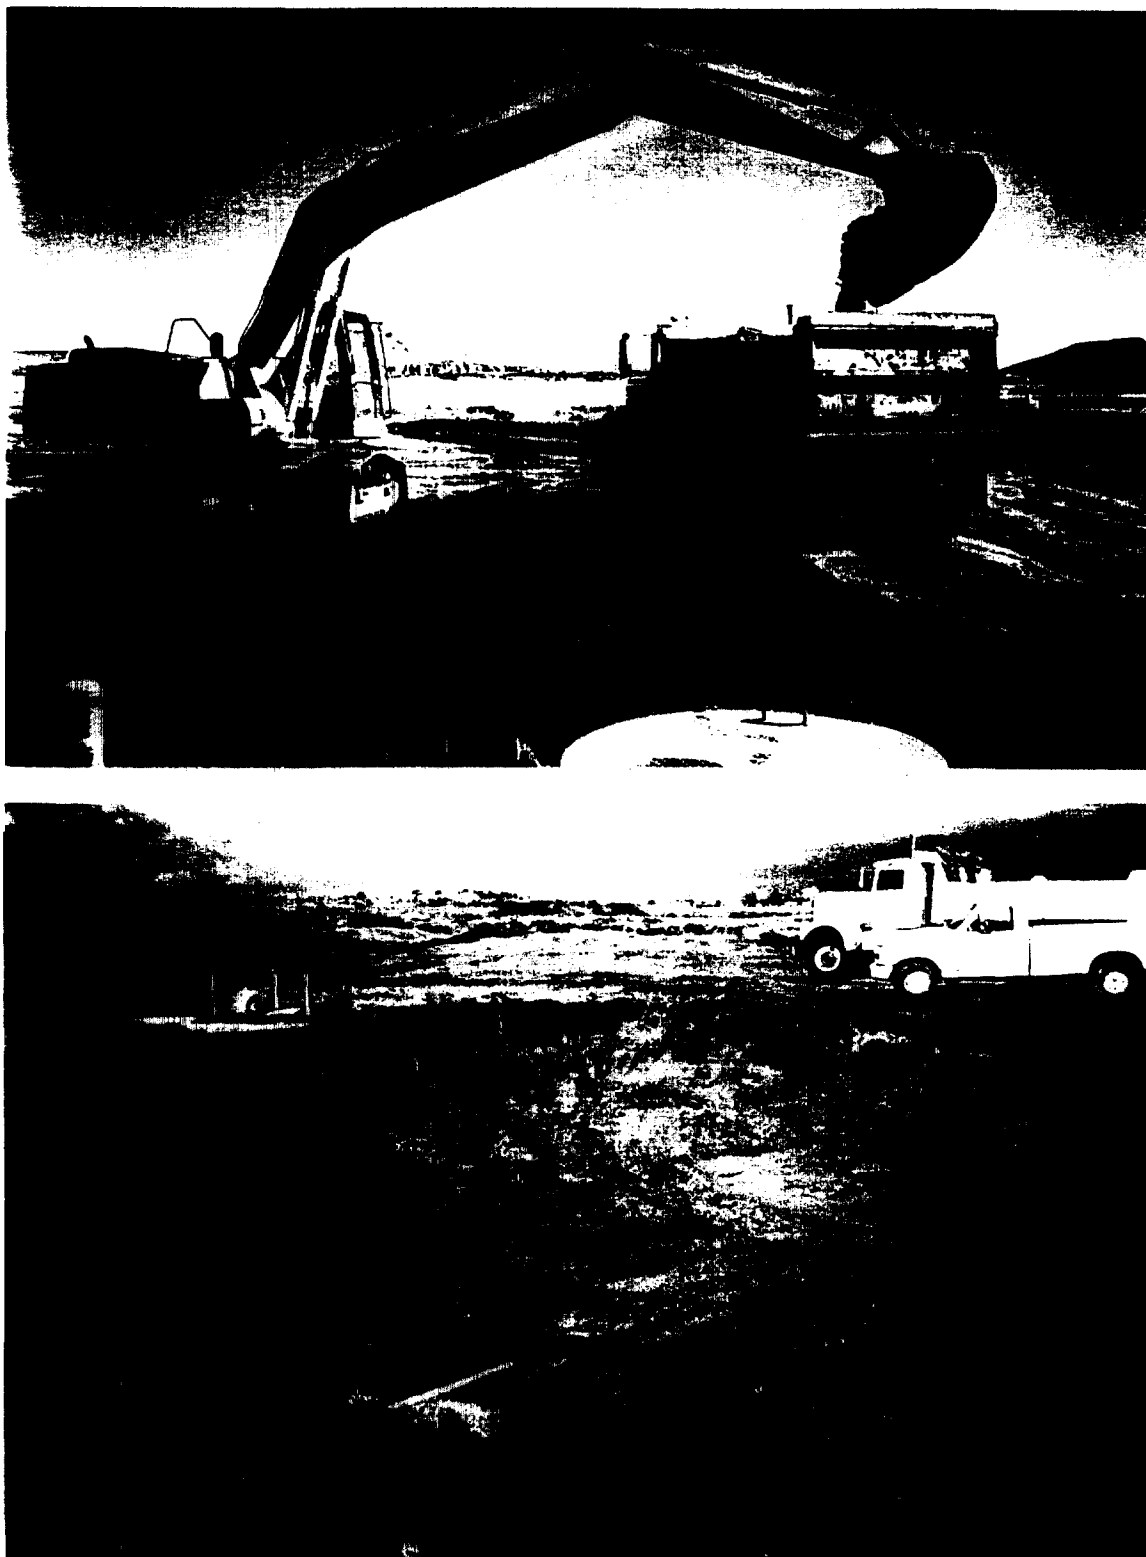
FIGURE 5-2 - Excavation of Hydrocarbon-Contaminated Soil at MW-20S Location

The soil at the West Pit located east of the separator and at the hydrocarbon-contaminated soil location near Well MW-20S was excavated to a depth of at least 4 feet as shown in Figure 5-2. The hydrocarbon staining extended to a depth of about 3 feet at both locations. However, excavation continued to a depth of 4 feet or greater to allow backfilling to proceed without having to wait for confirmatory sampling results. Confirmatory samples were not required and were not taken from the subsoil at these two locations because there is no action level for remediation of hydrocarbon-contaminated soils at depths greater than 4 feet. Survey control was used to confirm excavation depths prior to backfilling with clean soil.
